When Design Kills: A Case for Safety in Tall Buildings

Terri Meyer Boake

Professor, University of Waterloo

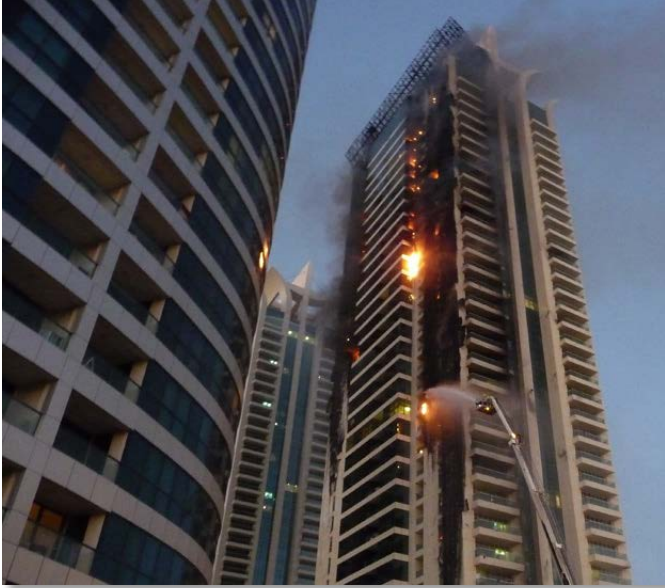
Tamweel Tower, Dubai | February 12, 2012

- 34 storey tower, 160 apartments
- Residential, operable windows, balconies
- No deaths or injuries
- Fire started on the outside of the building
- Assumed a cigarette ignited some trash on a balcony and the fire swept up the exterior
- Clad in non fire rated aluminum panels with thermoplastic core
- Residents still not able to move back into the building until late 2017
- Seen as a test case in the UAE for fire related insurance claims and repairs
- *In addition to replacing the cladding they will also be raising the height of the balconies*

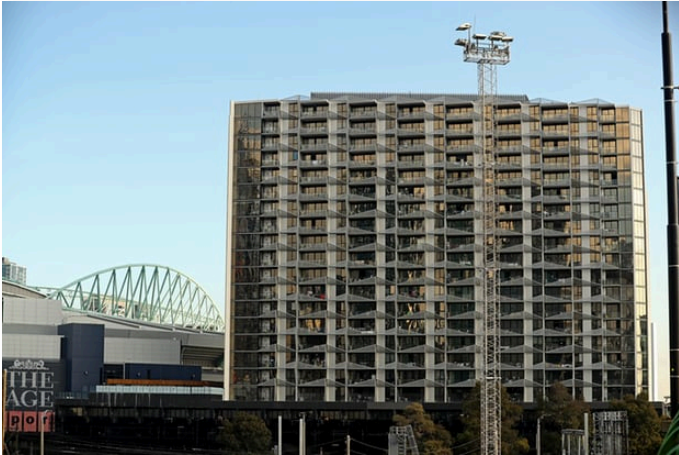
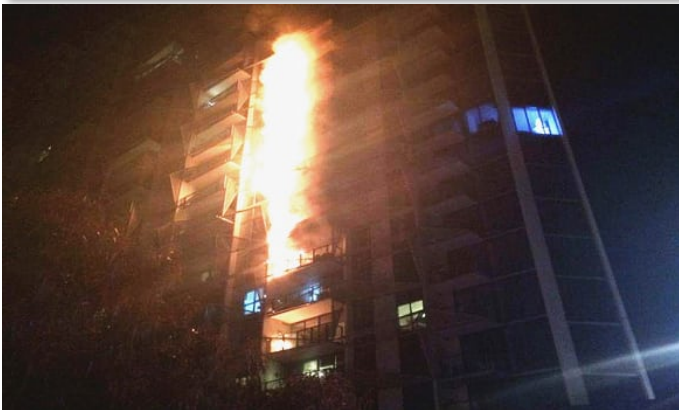
Lacrosse Apartments, Melbourne | November 25, 2014

- 21 storey tower, 200 apartments
- Residential, operable windows, balconies
- No deaths or injuries
- Fire started on the outside of the building
- A cigarette ignited some trash on a balcony and the fire swept up the exterior
- Fire swept from 8th to 21st floor in 11 minutes
- Clad in non fire rated aluminum panels with thermoplastic core
- The cladding has never been replaced and the building remains occupied
- The Australian government is looking into a process to deal with the many existing buildings with similar cladding

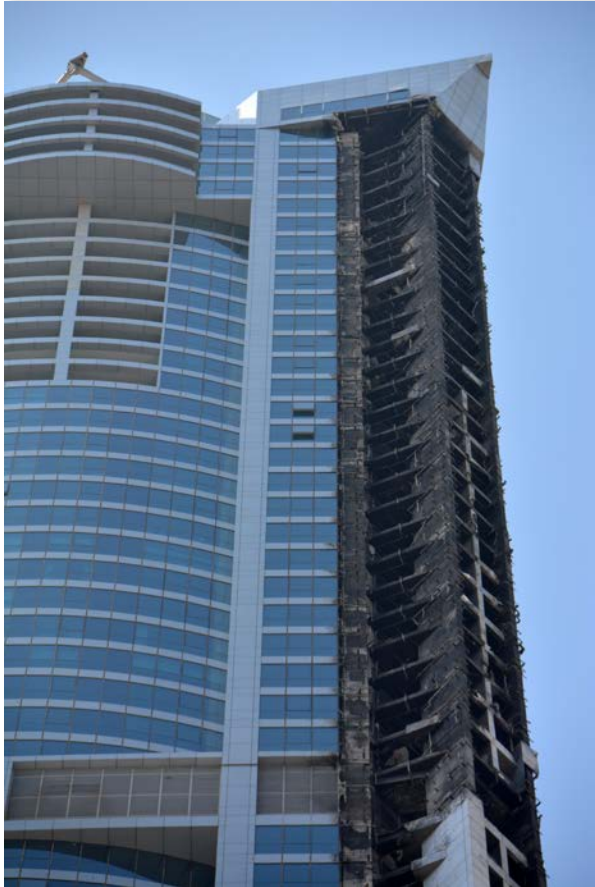
The Torch, Dubai | February 21, 2015, August 4, 2016

- 86 storey tower
- Residential, operable windows, balconies
- 4 people with minor injuries
- Fire started on the outside of the building both times
- Clad in non fire rated aluminum panels with thermoplastic core
- Fire #1: Fire alarms did not sound, people notified by occupants of an adjacent tower
- Fire #2: Alarms did sound
- Repairs to the building have yet to be completed

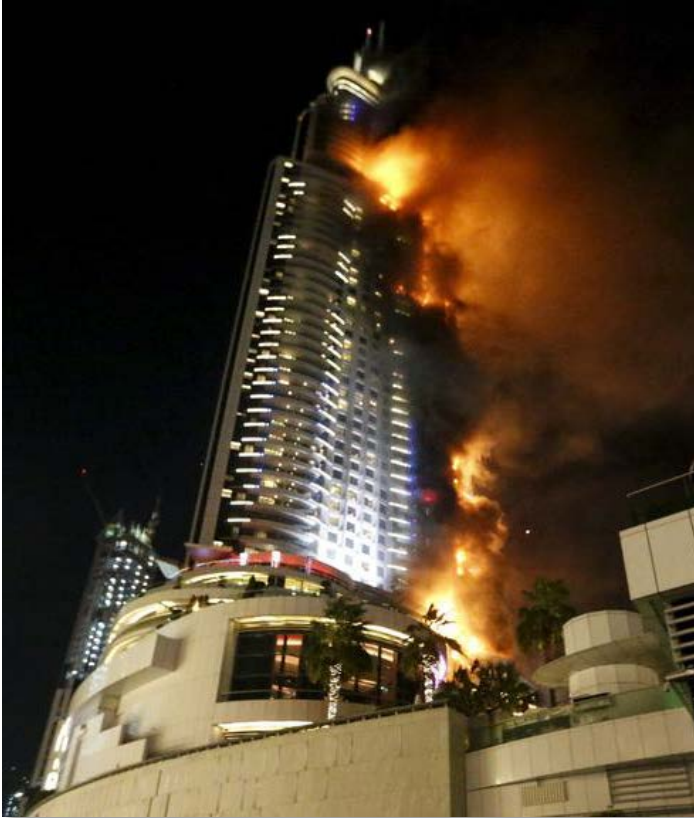
The Address, Dubai | December 31, 2015

- 63 storey tower
- Residential/hotel, operable windows, balconies
- Minor injuries
- Fire started on the outside of the building from an electrical fault from a wire for exterior lighting, located on a ledge between the 14th and 15th floors
- Clad in non fire rated Alubond aluminum panels with low density polyethylene core
- Fire alarms did not sound and sprinklers did not go off
- Emaar to receive Dh1.22 billion insurance claim
- Hotel set to reopen late 2017 (unsure if it has)

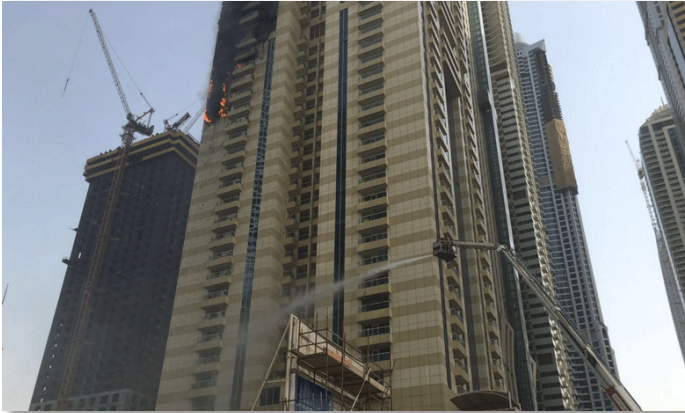
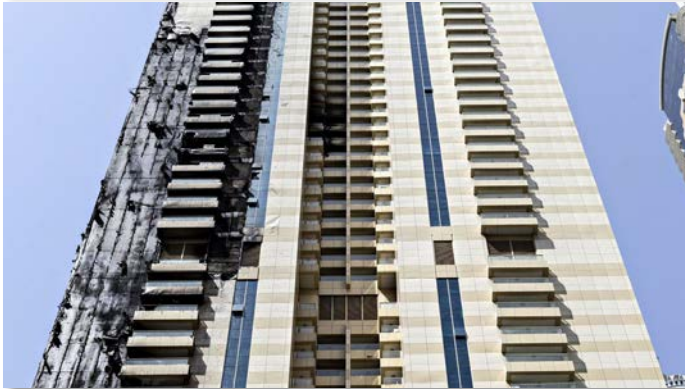
Sulafa Tower, Dubai | July 20, 2016

- 75 storey tower
- Residential, operable windows, balconies
- No injuries
- Fire started on the outside of the building from a discarded cigarette butt on the 61st floor
- Clad in non fire rated aluminum panels with low density polyethylene core
- Fire alarms did not sound and sprinklers did not go off
- 3 hours to extinguish
- 15 floors damaged
- Flames fanned by high winds

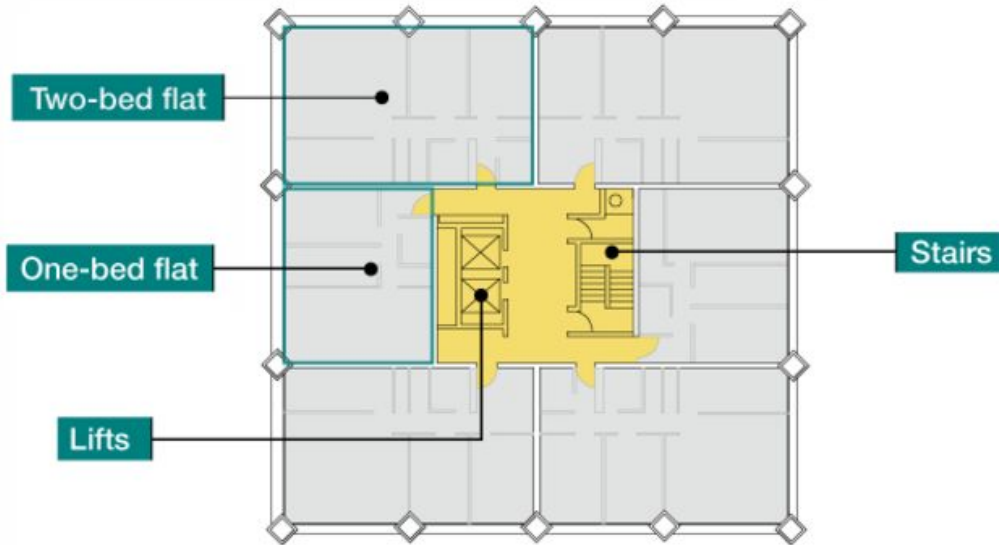
Typical residential floor in Grenfell Tower

- Only one exit stair for 300+ people
- No sprinkler system

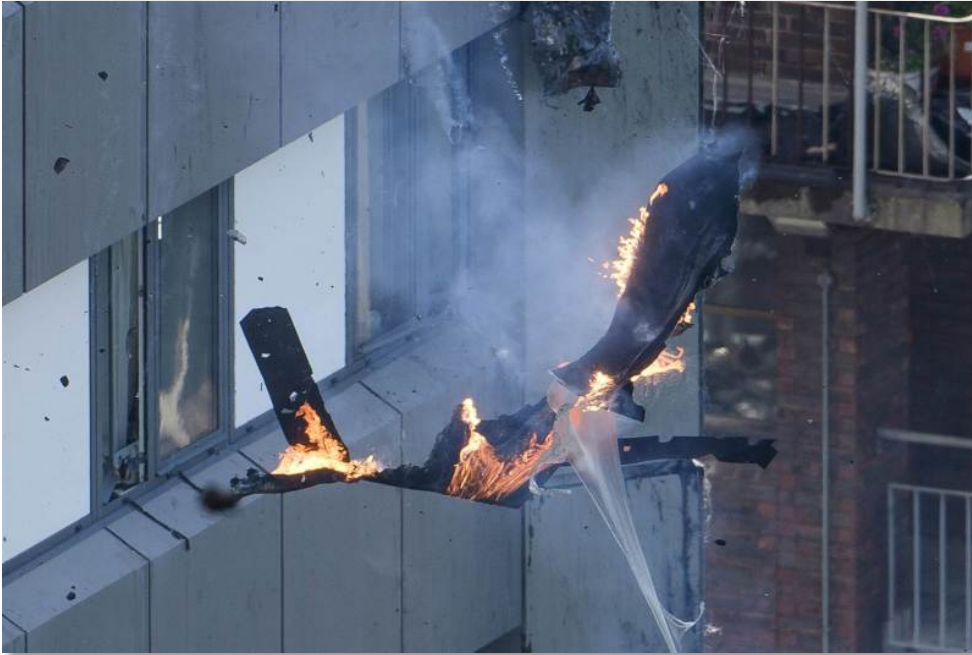
Low Density Polyethylene Insulation (LDPE):

- The softening of the aluminum combined with the melting of the LDPE insulation led to the panels falling off of the building.
- Fire resistance tests for the panels assume that the panels are sealed so that the edge condition does not expose the interior LDPE core

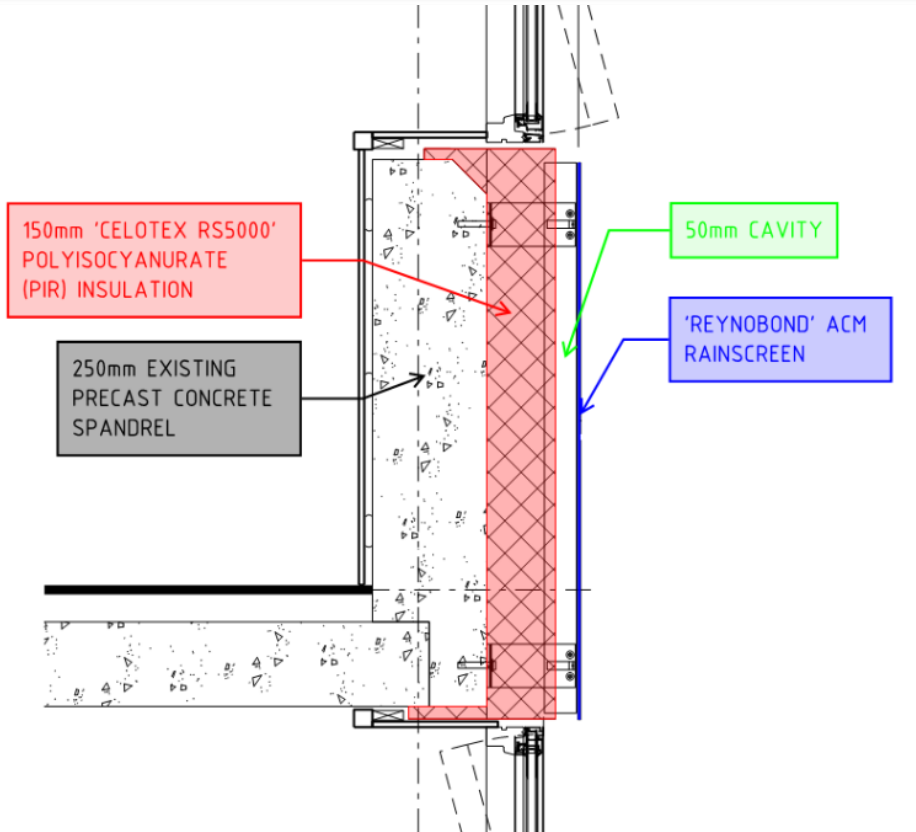
Spandrel panel failure in residential buildings

- Traditional precast concrete spandrel panel was non combustible so the separation of operable windows not a great problem for fire spread
- With a flaming exterior the spandrel panel provided no separation between the operable windows
- This would be a problem on low rise as well as high rise residential buildings.

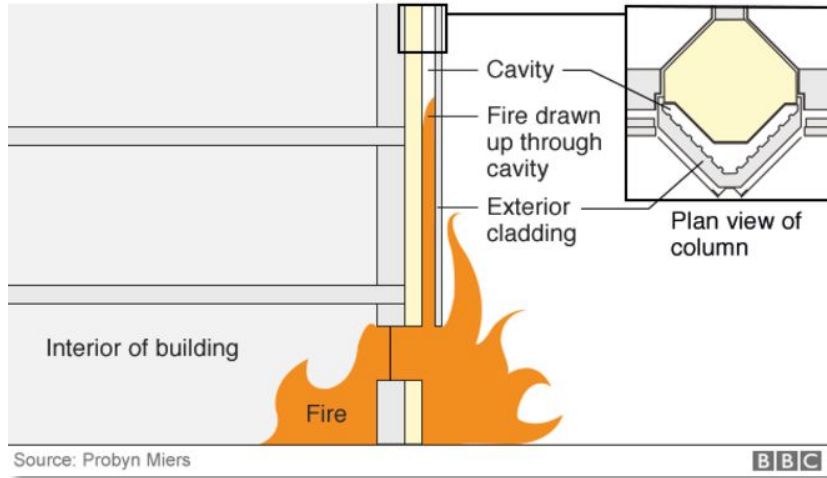
“Chimney effect” of exterior cladding

The odd shape of the Grenfell Tower columns meant that there was an airspace in front of and behind the Polyiso insulation layer, likely exacerbating the chimney effect.

- A rainscreen façade is a well established practice in Canada, and the need for firestopping to break the continuity of the channel is well known
- This applies to all types of façade cladding materials
- The vertical shafts created by the column covering in Grenfell led to the accelerated spread of the fire
- Essential to properly detail façades with cavity (rather than eliminate the cavity) as it is essential for air pressure equalization to prevent rain penetration
- Also block corners so fire or water is not pushed to adjacent façade cavities
- Cavity insulation should be of a non combustible type or if flammable, properly encapsulated
- Was not an issue in the UAE fires as no cavity there
- More education in detailing is needed

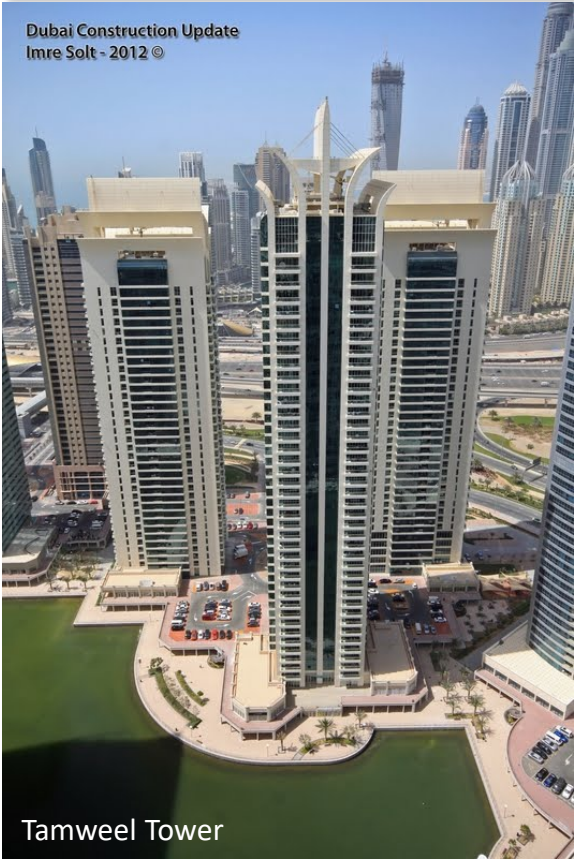
Tamweel Tower

- In the Tamweel fire there is mention of a forthcoming increase in the balcony railing height as a fire prevention
- In theory the balcony should act as a fire break ledge, unless itself clad in flammable materials
- Balconies would also need to be continuous to act as a ledge break

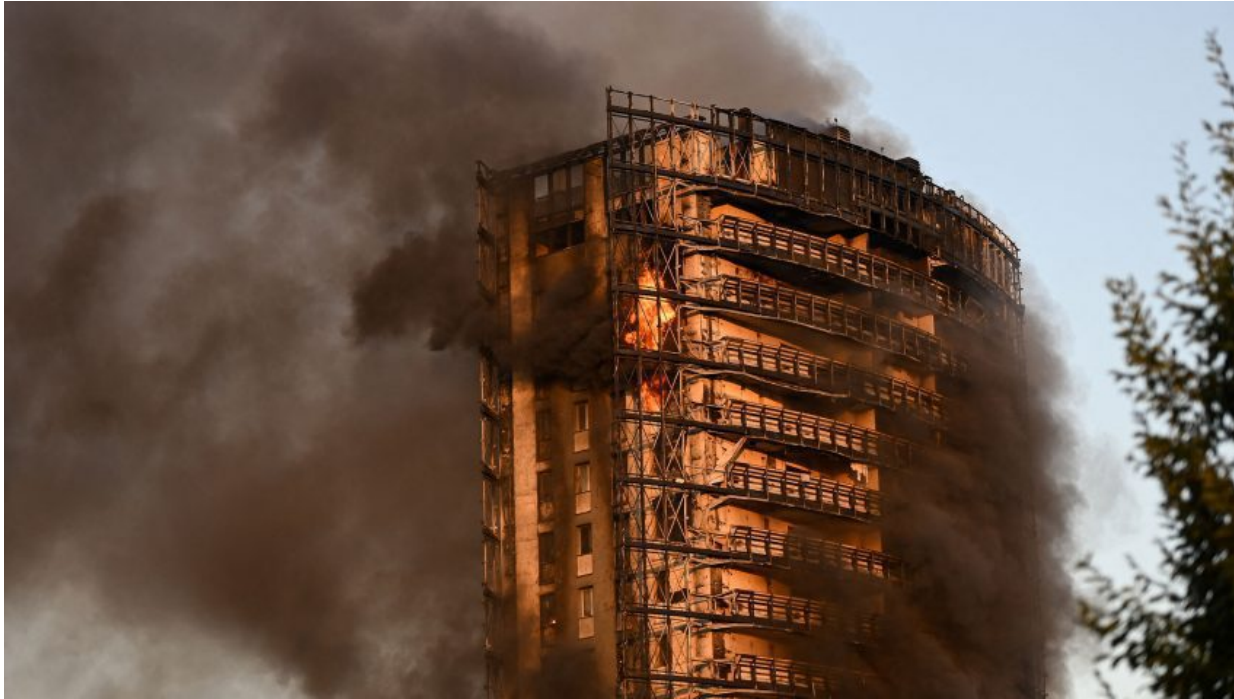
Torre del More Fire

“When we arrived, the fire had a normal course, that is from the 15th floor upwards,” a firefighter told Corriere della Sera.

"When the first team entered, the tower was immediately engulfed in flames and the fire went down unnaturally, as evidence that it found in the lining not only non-fireproof material but also fuel capable of extending the fire quickly.“

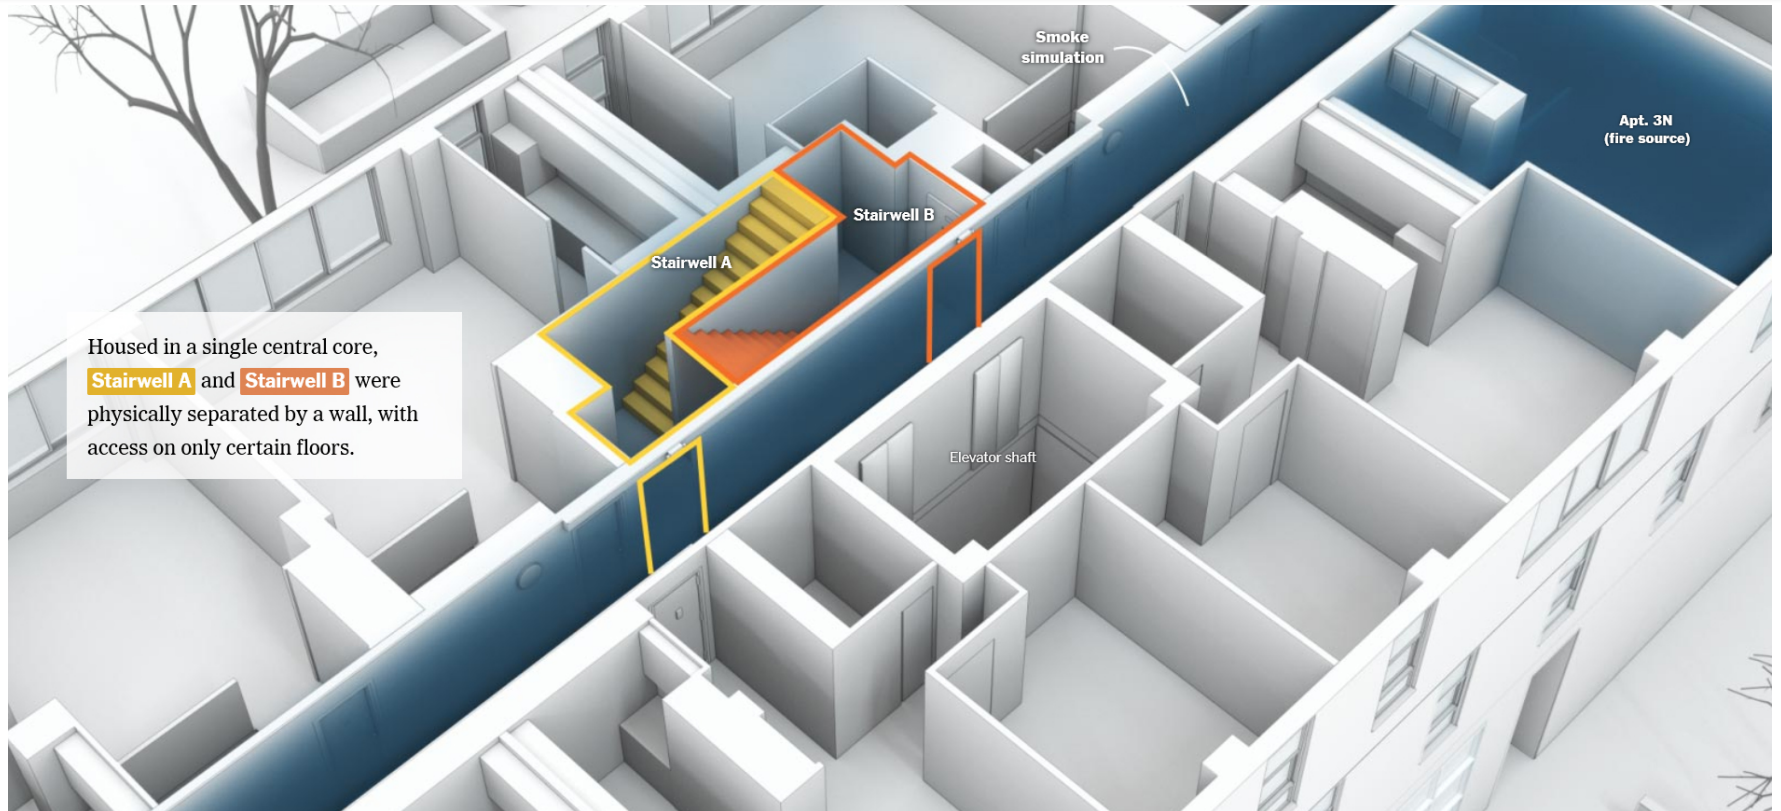
Bronx Fire

Housed in a single central core, **Stairwell A** and **Stairwell B** were physically separated by a wall, with access on only certain floors.
