When Design Kills: A Case for Safety in Tall Buildings

Terri Meyer Boake

Professor, University of Waterloo

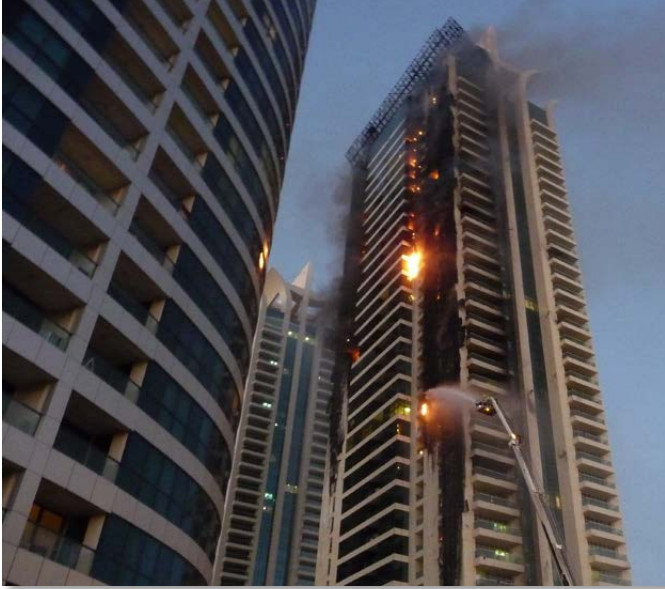
Tamweel Tower, Dubai | February 12, 2012

- 34 storey tower, 160 apartments
- Residential, operable windows, balconies
- No deaths or injuries
- Fire started on the outside of the building
- Assumed a cigarette ignited some trash on a balcony and the fire swept up the exterior
- Clad in non fire rated aluminum panels with thermoplastic core
- Residents still not able to move back into the building until late 2017
- Seen as a test case in the UAE for fire related insurance claims and repairs
- *In addition to replacing the cladding they will also be raising the height of the balconies*

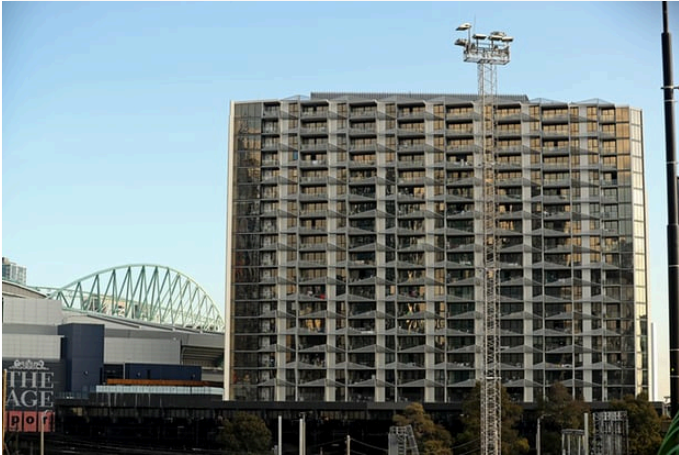
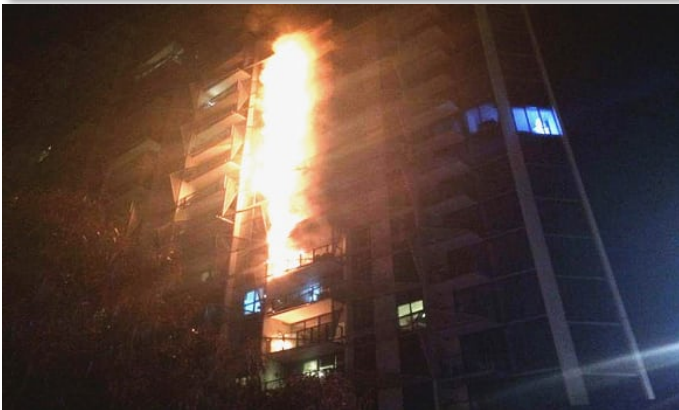
Lacrosse Apartments, Melbourne | November 25, 2014

- 21 storey tower, 200 apartments
- Residential, operable windows, balconies
- No deaths or injuries
- Fire started on the outside of the building
- A cigarette ignited some trash on a balcony and the fire swept up the exterior
- Fire swept from 8th to 21st floor in 11 minutes
- Clad in non fire rated aluminum panels with thermoplastic core
- The cladding has never been replaced and the building remains occupied
- The Australian government is looking into a process to deal with the many existing buildings with similar cladding

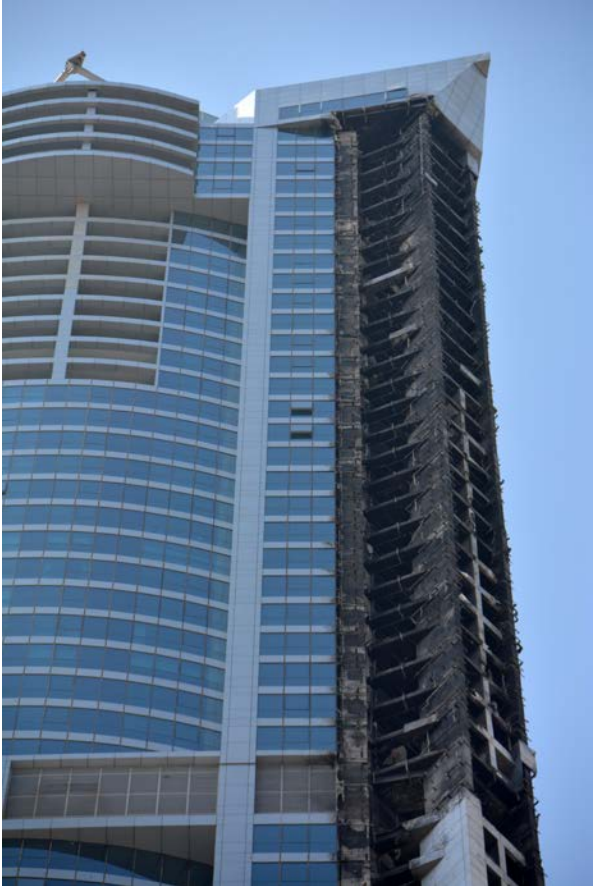
The Torch, Dubai | February 21, 2015, August 4, 2016

- 86 storey tower
- Residential, operable windows, balconies
- 4 people with minor injuries
- Fire started on the outside of the building both times
- Clad in non fire rated aluminum panels with thermoplastic core
- Fire #1: Fire alarms did not sound, people notified by occupants of an adjacent tower
- Fire #2: Alarms did sound
- Repairs to the building have yet to be completed

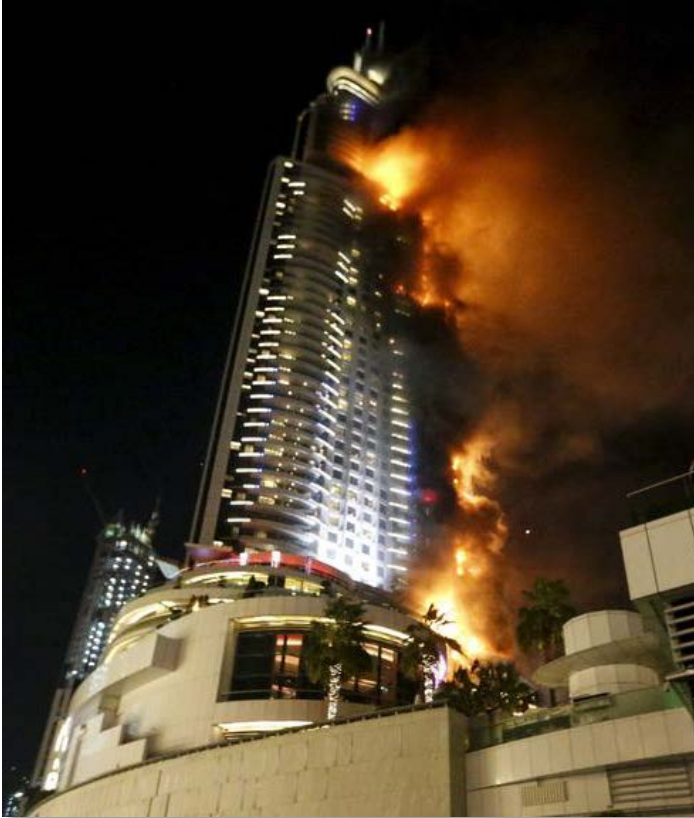
The Address, Dubai | December 31, 2015

- 63 storey tower
- Residential/hotel, operable windows, balconies
- Minor injuries
- Fire started on the outside of the building from an electrical fault from a wire for exterior lighting, located on a ledge between the 14th and 15th floors
- Clad in non fire rated Alubond aluminum panels with low density polyethylene core
- Fire alarms did not sound and sprinklers did not go off
- Emaar to receive Dh1.22 billion insurance claim
- Hotel set to reopen late 2017 (unsure if it has)

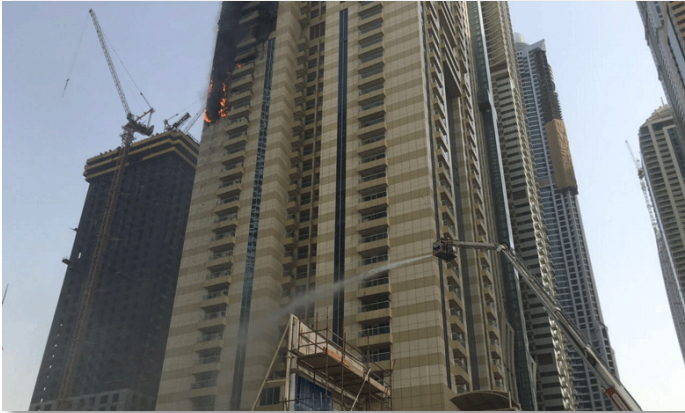
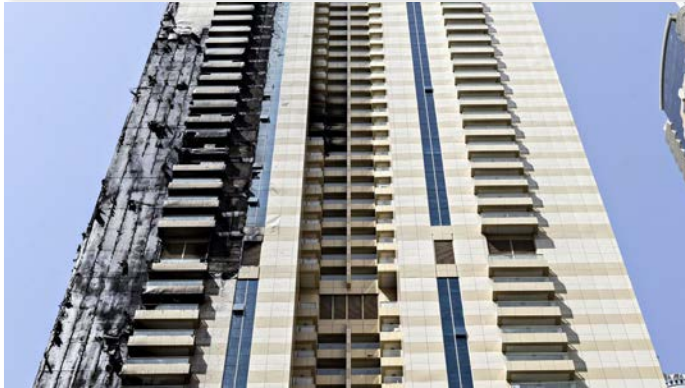
Sulafa Tower, Dubai | July 20, 2016

- 75 storey tower
- Residential, operable windows, balconies
- No injuries
- Fire started on the outside of the building from a discarded cigarette butt on the 61st floor
- Clad in non fire rated aluminum panels with low density polyethylene core
- Fire alarms did not sound and sprinklers did not go off
- 3 hours to extinguish
- 15 floors damaged
- Flames fanned by high winds

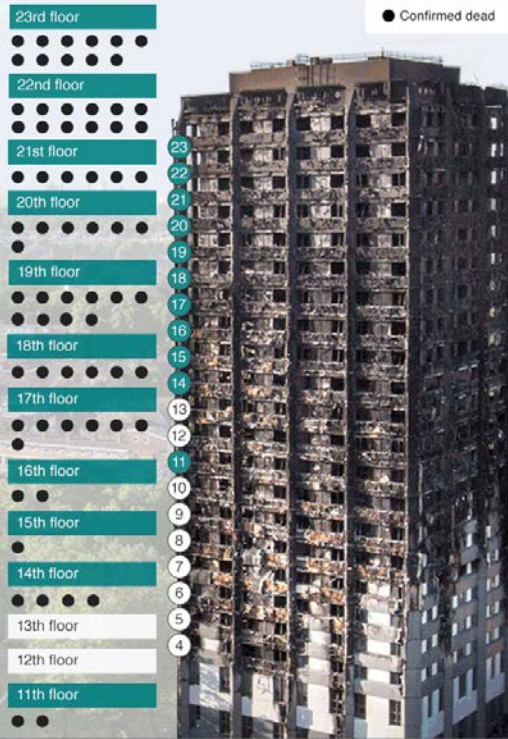
Where the Grenfell Tower fire victims lived

- 27 storey tower
- Residential, operable windows (summer night, open), no balconies
- 71 deaths
- Fire started on the inside of the building from a malfunctioning fridge that burnt through to the cavity
- Spread from 4th floor upwards in 15 minutes
- Re-clad in non fire rated aluminum panels with low density polyethylene core using a rain screen with an additional 150mm polyisocyanurate insulation and a 50mm continuous cavity
- No fire alarms in building
- Single stairwell

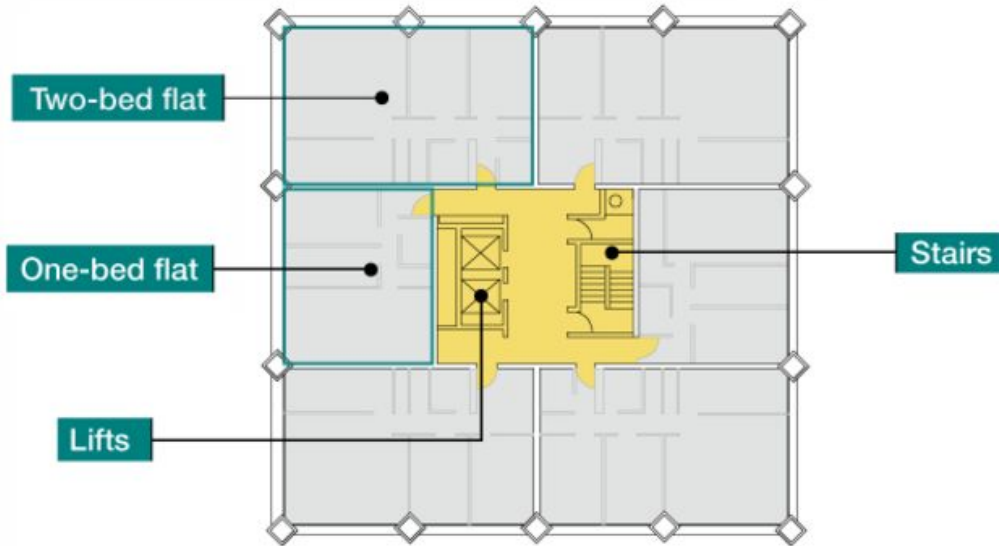
Typical residential floor in Grenfell Tower

- Only one exit stair for 300+ people
- No sprinkler system

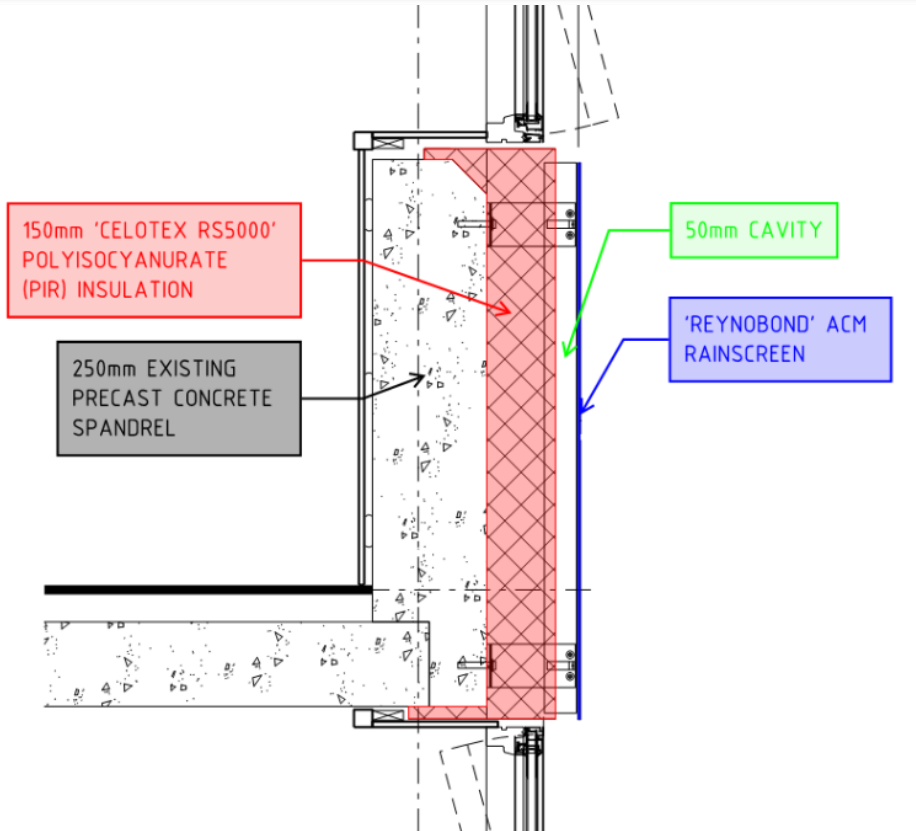
Spandrel panel failure in residential buildings

- Traditional precast concrete spandrel panel was non combustible so the separation of operable windows not a great problem for fire spread
- With a flaming exterior the spandrel panel provided no separation between the operable windows
- This would be a problem on low rise as well as high rise residential buildings.

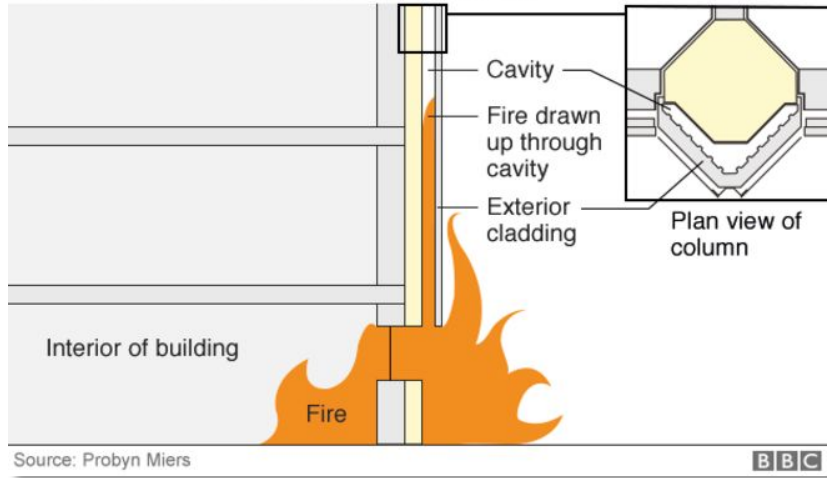
“Chimney effect” of exterior cladding

The odd shape of the Grenfell Tower columns meant that there was an airspace in front of and behind the Polyiso insulation layer, likely exacerbating the chimney effect.

- A rainscreen façade is a well established practice in Canada, and the need for firestopping to break the continuity of the channel is well known
- This applies to all types of façade cladding materials
- The vertical shafts created by the column covering in Grenfell led to the accelerated spread of the fire
- Essential to properly detail façades with cavity (rather than eliminate the cavity) as it is essential for air pressure equalization to prevent rain penetration
- Also block corners so fire or water is not pushed to adjacent façade cavities
- Cavity insulation should be of a non combustible type or if flammable, properly encapsulated
- Was not an issue in the UAE fires as no cavity there
- More education in detailing is needed

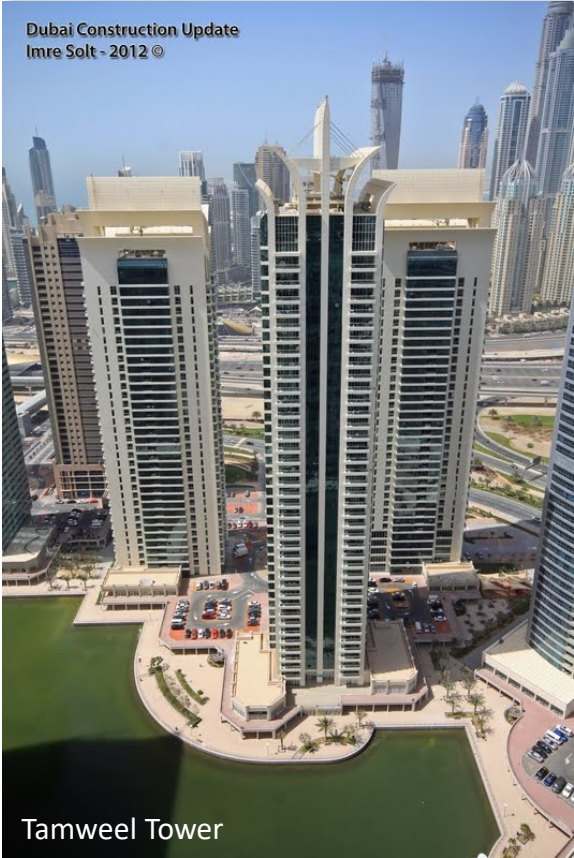
Tamweel Tower

- In the Tamweel fire there is mention of a forthcoming increase in the balcony railing height as a fire prevention
- In theory the balcony should act as a fire break ledge, unless itself clad in flammable materials
- Balconies would also need to be continuous to act as a ledge break

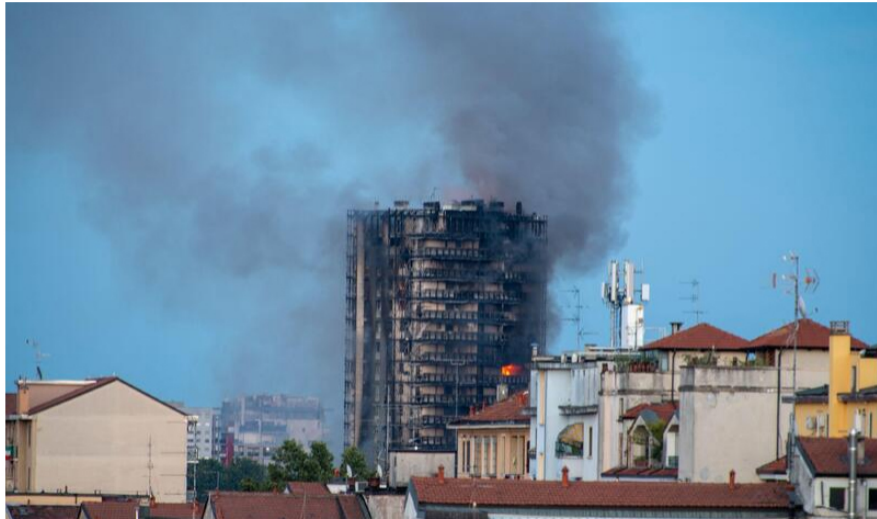
The tower was clad in aluminium composite material (ACM) – the same material as used on Grenfell Tower.

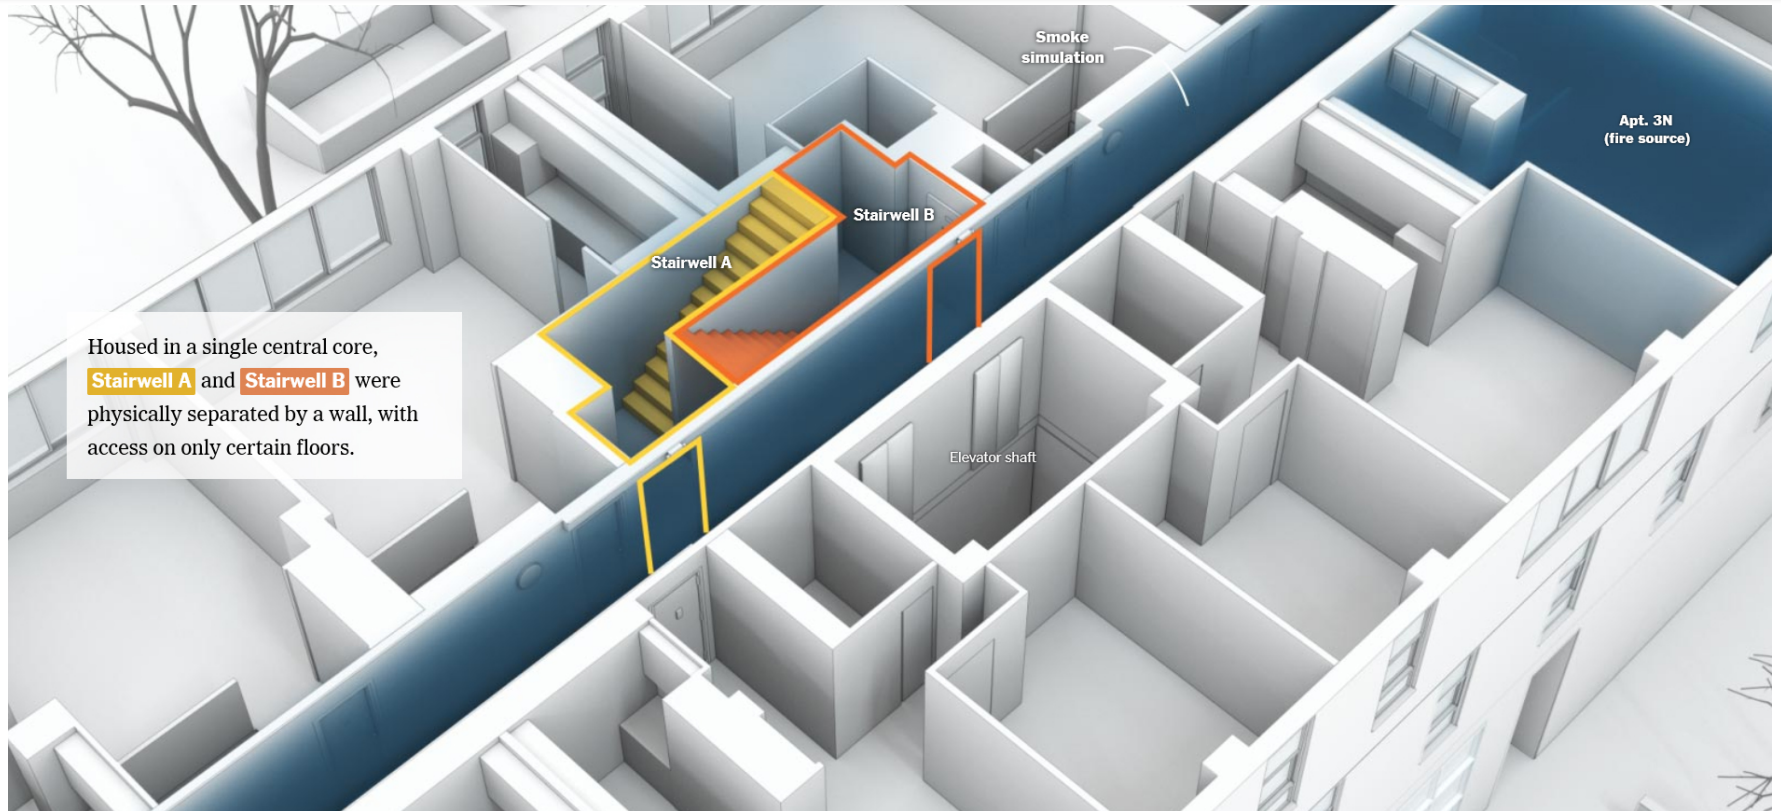
Housed in a single central core, **Stairwell A** and **Stairwell B** were physically separated by a wall, with access on only certain floors.

These interlocking “scissor stairs” are legal under the New York City building code in residential buildings, but fire safety experts have criticized them.
