When Design Kills: A Case for Safety in Tall Buildings

Terri Meyer Boake

Professor, University of Waterloo

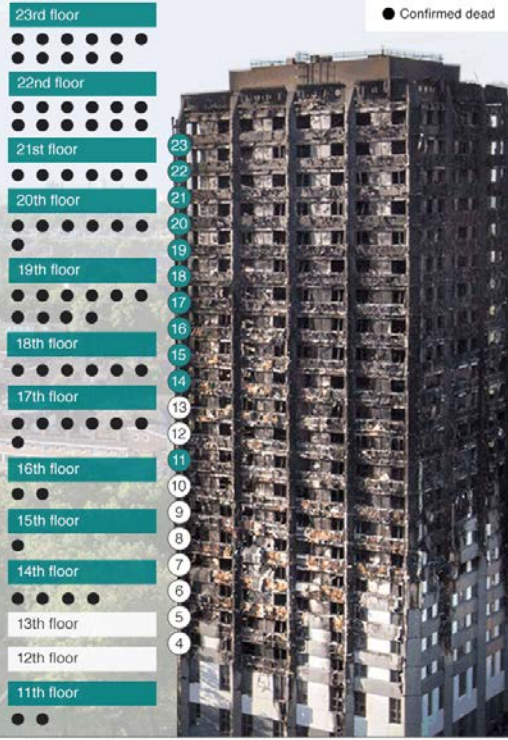
Where the Grenfell Tower fire victims lived

Graphic does not include Victoria King, 71, and her daughter, Alexandra Atala, 40, who also died in the blaze, details of where they lived have not been released. Baby Logan Gomes, who was stillborn in hospital on 14 June after his parents escaped the tower block, has also been recorded by police as a victim of the fire. They include people visiting friends and family in the block.

- 27 storey tower
- Residential, operable windows (summer night, open), no balconies
- 71 deaths
- Fire started on the inside of the building from a malfunctioning fridge that burnt through to the cavity
- Spread from 4th floor upwards in 15 minutes
- Re-clad in non fire rated aluminum panels with low density polyethylene core using a rain screen with an additional 150mm polyisocyanurate insulation and a 50mm continuous cavity
- No fire alarms in building
- Single stairwell

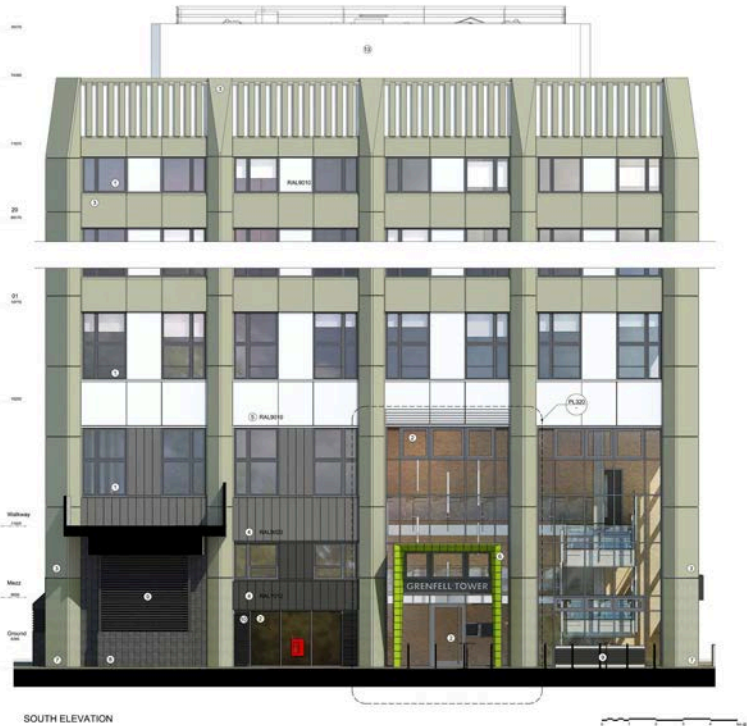
- In a statement on its website, Omnis Exteriors said panels such as Reynobond PE should only be used with “a non-combustible insulation material such as mineral fibre” if they are to be installed on high-rise buildings.
- The fire resistant panel was dropped due to cost reasons
- Massive failures in communication
- Massive investigation underway, changes coming to the British codes.

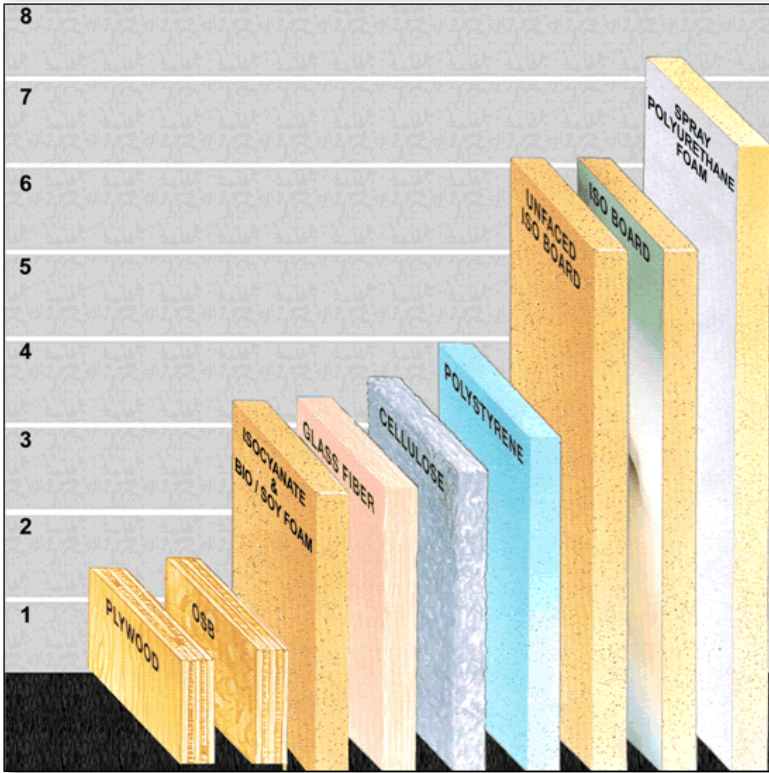
Aluminum composite wall panels insulation core varies from 3 to 6mm (1/8" to 1/4")

SERIOUSLY WITH 6MM OF INSULATION IT'S NOT CONTRIBUTING MUCH TO THE R-VALUE....

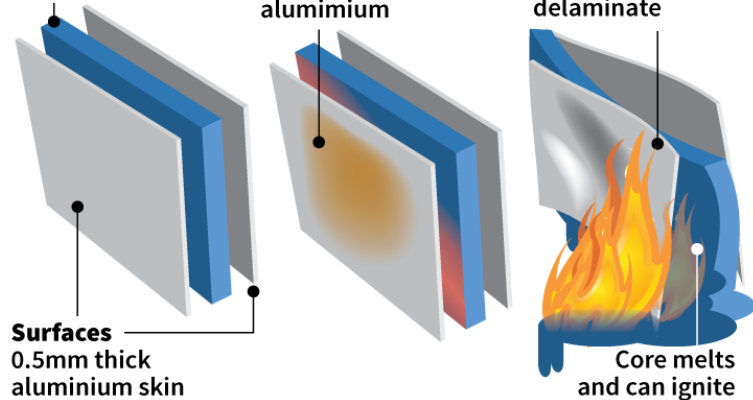
Heat from a fire will
conduct quickly to the
core through thin
aluminium

Core loses ability to
bind, causing outer
skins to deform and
delaminate

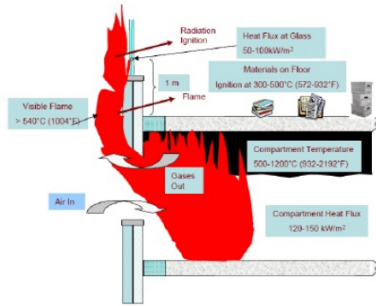
Figure 12.3. Exterior curtain wall and floor fire exposure mechanisms. (Courtesy of Aon Fire Protection Engineering)

In the UAE there was a suggestion of implementing a non combustible fire break of up to 10m in width on high rise towers so that the fire could be prevented from engulfing the entire building.

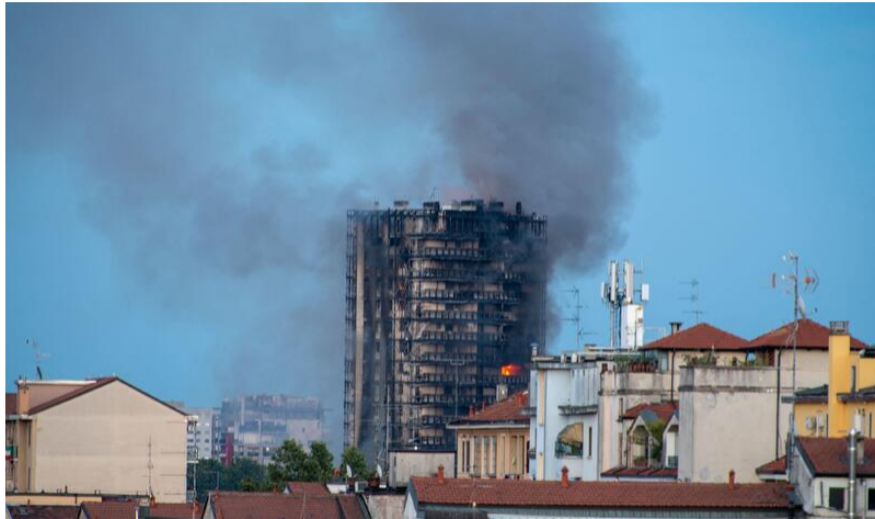
The tower was clad in aluminium composite material (ACM) – the same material as used on Grenfell Tower.

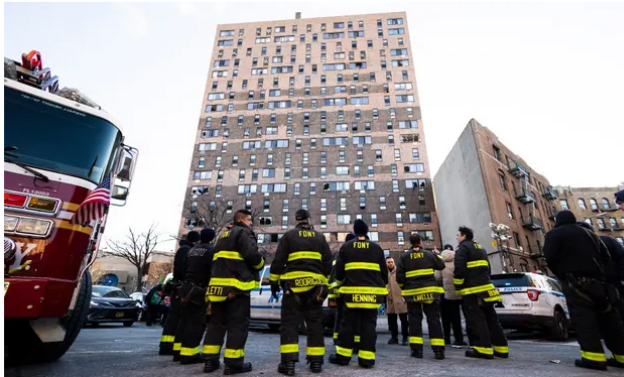
📷 The building on East 181st Street. Hundreds of firefighters responded to the alarm. Photograph: Justin Lane/EPA

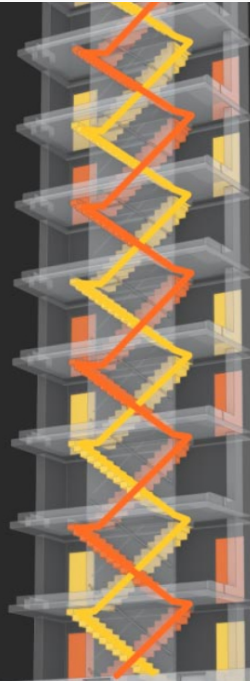
Stairwells

These interlocking “scissor stairs” are legal under the New York City building code in residential buildings, but fire safety experts have criticized them.

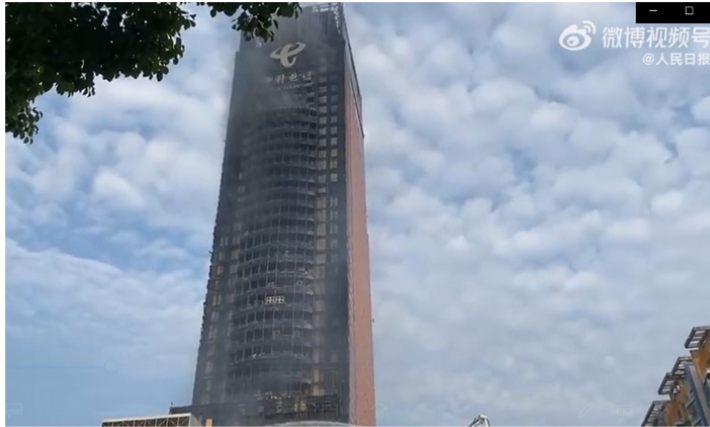
The large fire that engulfed a high-rise building belonging to China Telecom in Changsha, Central China's Hunan Province, has been put out. No casualties were reported, the group announced Friday on China's Twitter-like Sina Weibo.
