When Design Kills: A Case for Safety in Tall Buildings

Terri Meyer Boake

Professor, University of Waterloo

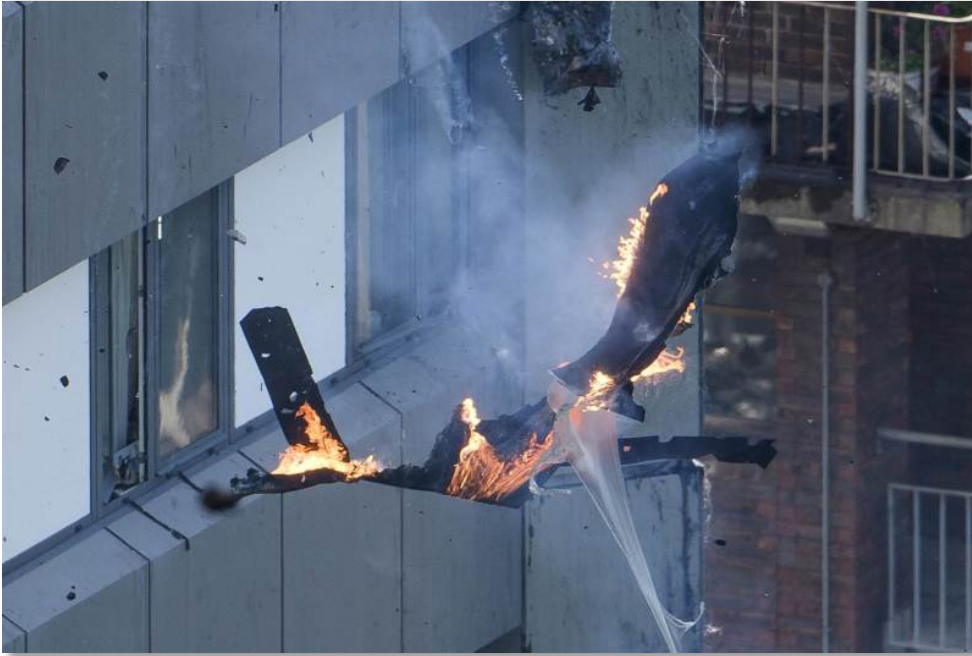
Low Density Polyethylene Insulation (LDPE):

- The softening of the aluminum combined with the melting of the LDPE insulation led to the panels falling off of the building.
- Fire resistance tests for the panels assume that the panels are sealed so that the edge condition does not expose the interior LDPE core

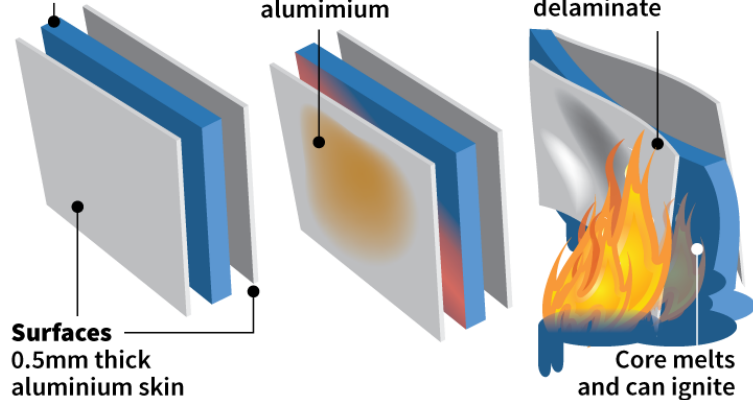
Heat from a fire will
conduct quickly to the
core through thin
aluminium

Core loses ability to
bind, causing outer
skins to deform and
delaminate

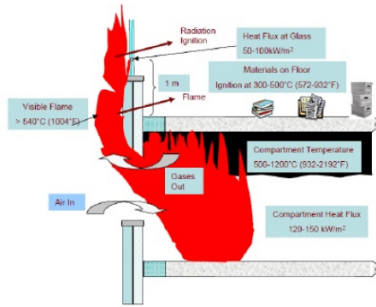
Figure 12.3. Exterior curtain wall and floor fire exposure mechanisms. (Courtesy of Aon Fire Protection Engineering)

In the UAE there was a suggestion of implementing a non combustible fire break of up to 10m in width on high rise towers so that the fire could be prevented from engulfing the entire building.

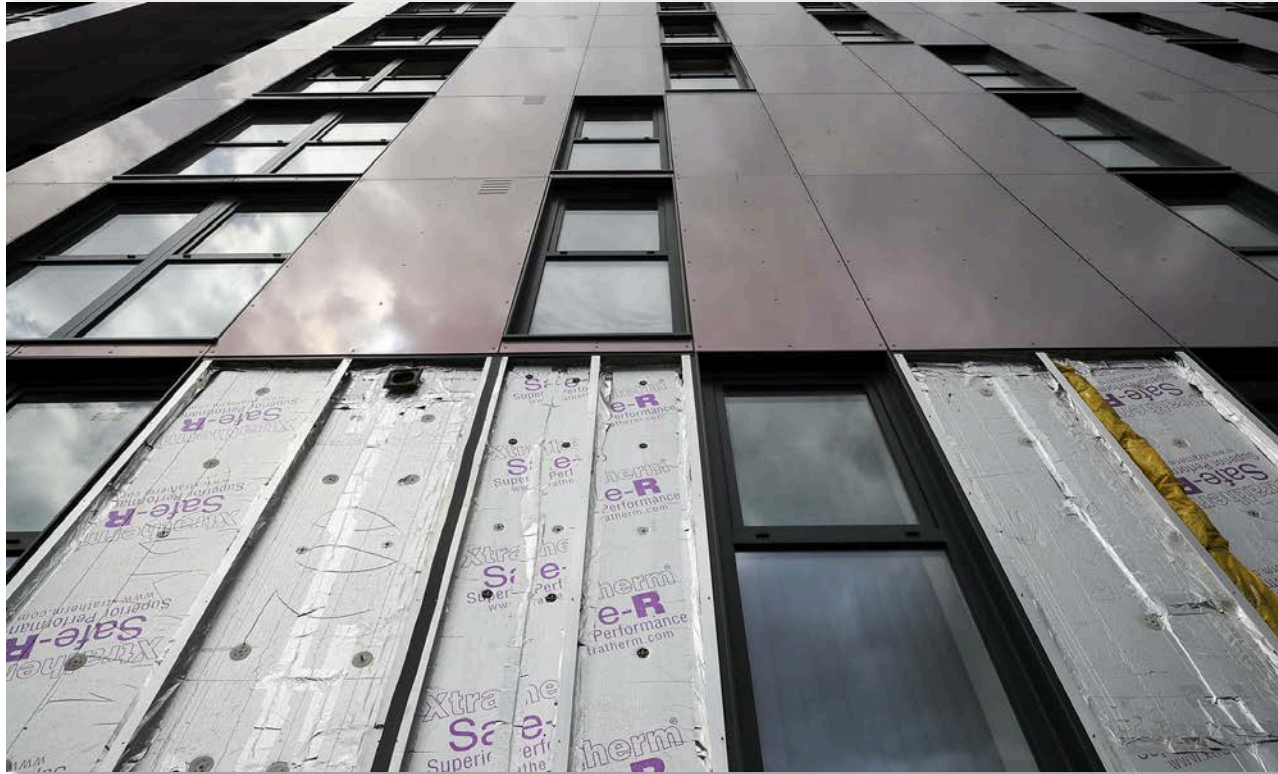
- One of the issues with the current “witch hunt” that is underway in the UK is that it lacks rigor and transparency.
- Tests are being conducted on the façade material, many failing, but there is no rigor in examine the cavity, air space and insulation behind – which exacerbated the Grenfell fire.

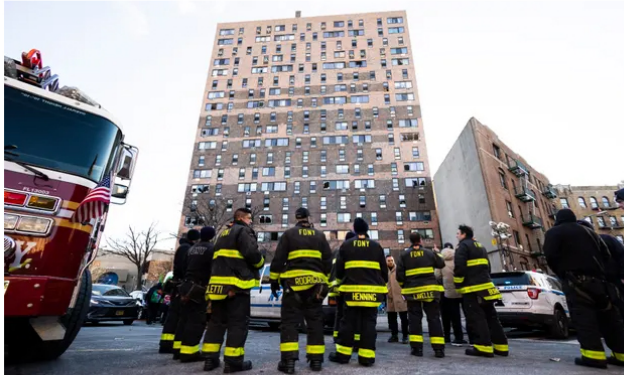
📷 The building on East 181st Street. Hundreds of firefighters responded to the alarm. Photograph: Justin Lane/EPA

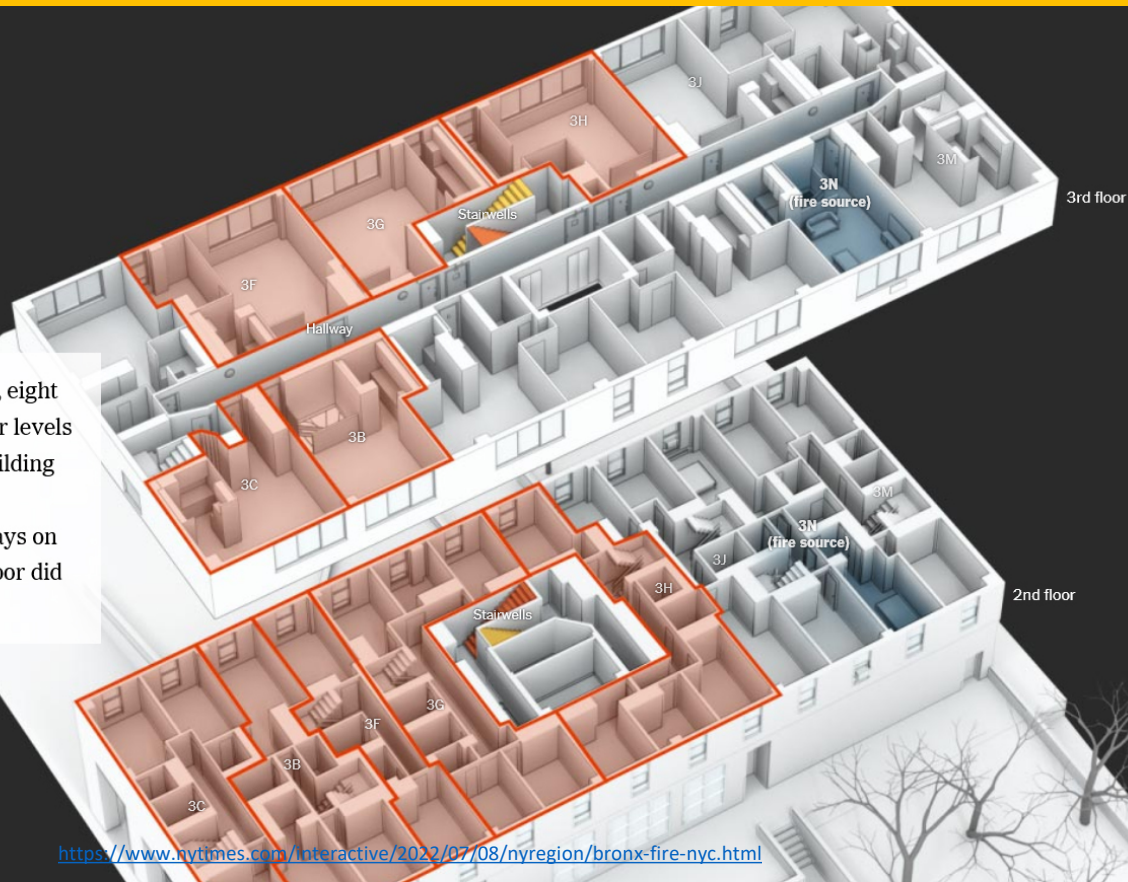
Scissor stair, 2 storey units, dead end corridors, confusion

On the third floor, for example, eight units were duplexes with lower levels on the second floor. But the building stairwells and elevators were accessible only through hallways on the third floor — the second floor did not have hallways.

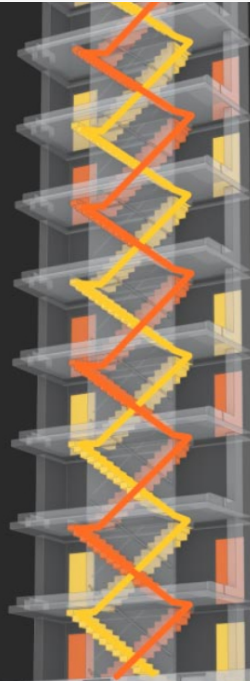
Stairwells

These interlocking “scissor stairs” are legal under the New York City building code in residential buildings, but fire safety experts have criticized them.
